**Flood Control Project Maintenance
Levee Inspections**

Maintenance Issue Types Only, Levee Inspection Report By Mile - Spring 2018

Reclamation District No. 0563 Tyler Island

Waterway	Bank	Unit Miles	Inspection Start/End	Inspector
Unit No. 01 Georgiana Slough (Tyler Island)	Left	12.11	03/30/2018 03/30/2018	Keith Millard

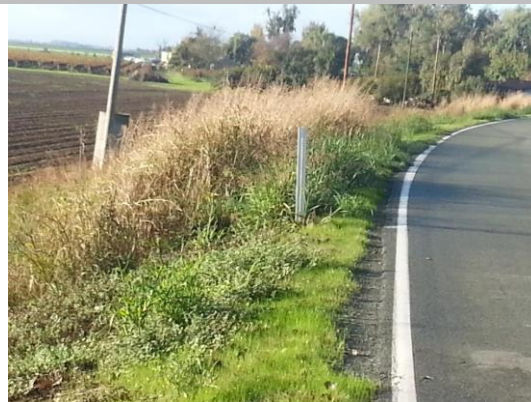
Photo 1 of 2 : SP_2018_RD0563_210_138_20180305_00114.jpg

Looking west at dense veg on landward slope.

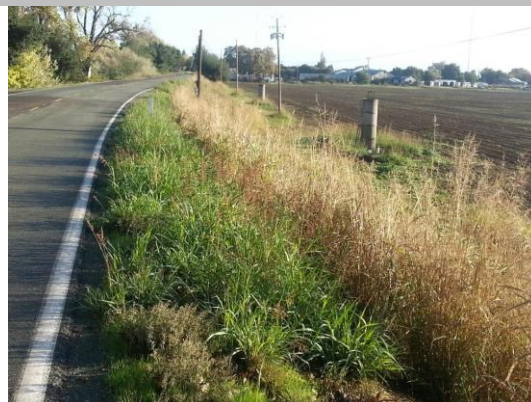
Photo 2 of 2 : SP_2018_RD0563_210_138_20180305_00115.jpg

Looking east at dense veg on landward slope.

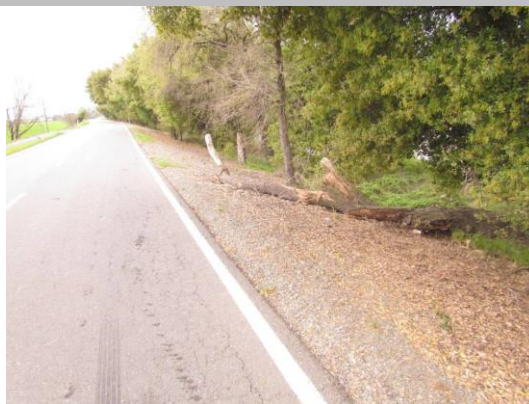
Photo 1 of 2 : SP_2018_RD0563_210_32_20180305_00023.jpg

Looking downstream at tree branch on waterward slope. (Spring 2017)

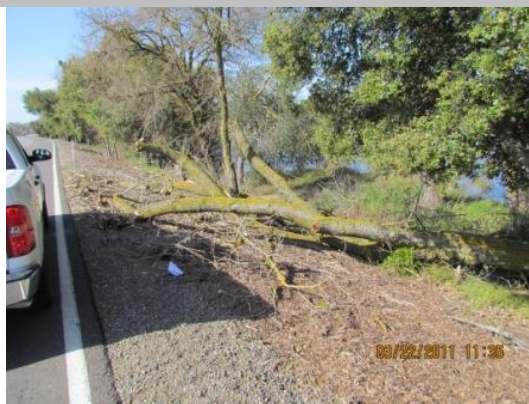
Photo 2 of 2 : SP_2018_RD0563_210_32_20180305_00024.jpg

Looking downstream at fallen tree limb on waterside slope. (Spring 2016)

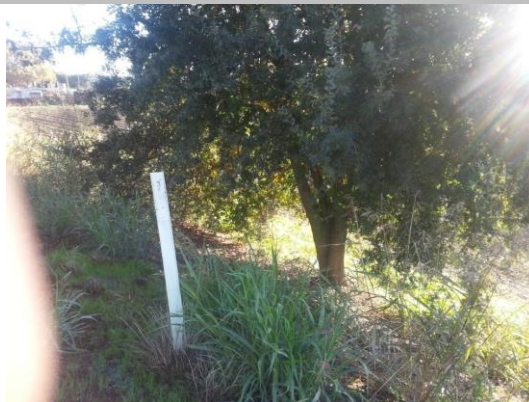
Photo 1 of 1 : SP_2018_RD0563_210_168_20180305_00131.jpg

Looking east at untrimmed tree on landward slope.

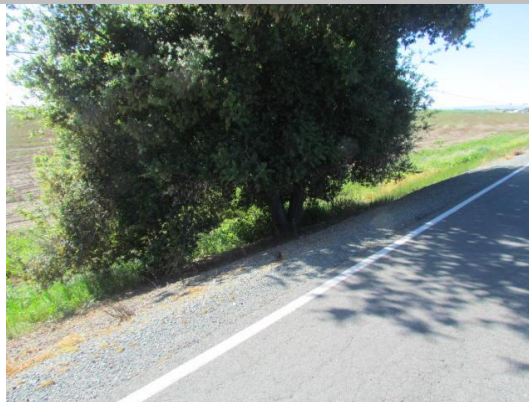
Photo 1 of 1 : SP_2018_RD0563_210_135_20180305_00113.jpg

LM Start	0.33	Rating **	M	Issue No.	135
LM End	0.33	Issue Type +	Ma	Location *	LS
Category	Earthen Levee			GPS Latitude/Longitude	
				Start	End
Item	Trim / Thin Trees			38.231548 °	38.231548 °
				-121.521140 °	-121.521140 °
DWR ID	DWR_RD0563_01_f_2015_135				
Comment Code					
T1 : Trim trees to at least five feet above ground level.					
Inspector Comment					
Untrimmed tree on landward slope.

Looking southeast at untrimmed tree on landward slope.

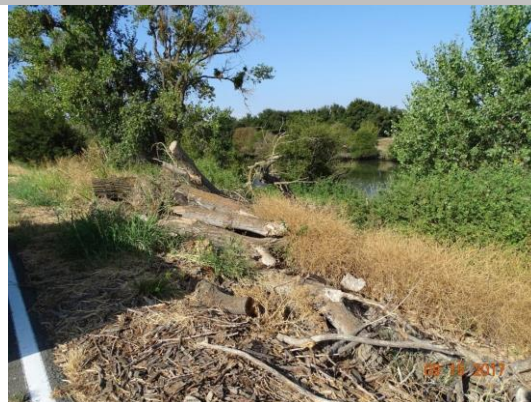
Photo 1 of 1 : SP_2018_RD0563_210_114_20180305_00095.jpg

Looking southwest at the waterside slope.

LM Start	0.43	Rating **	C	Issue No.	26
LM End	0.43	Issue Type +	Ma	Location *	WS
Category	Earthen Levee			GPS Latitude/Longitude	
				Start	End
Item	Slope Stability			38.230460 °	38.230460 °
				-121.522324 °	-121.522324 °
DWR ID	DWR_RD0563_01_f_2013_26				
Comment Code					
S3 : Repair the levee slope damaged by vehicle traffic and prevent access where possible.					
Inspector Comment					
River access is overgrown and no longer is use, and edge of pavement has been repaired to prevent further erosion.

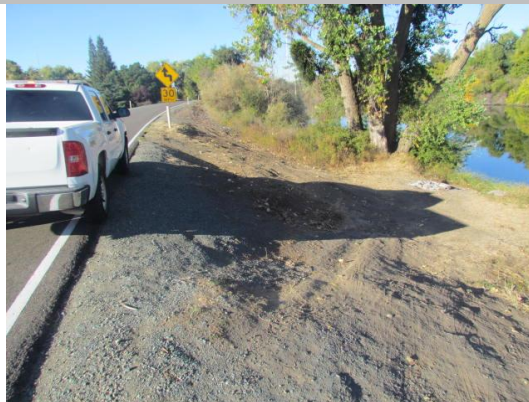
Photo 1 of 2 : SP_2018_RD0563_210_143_20180305_00120.jpg

LM Start	0.56	Rating **	M	Issue No.	143
LM End	0.56	Issue Type +	Ma	Location *	WS
Category	Earthen Levee			GPS Latitude/Longitude	
				Start	End
Item	Slope Stability			38.228930 °	38.228930 °
				-121.523935 °	-121.523935 °
DWR ID	DWR_RD0563_01_f_2014_143				
Comment Code					
S3 : Repair the levee slope damaged by vehicle traffic and prevent access where possible.					
Inspector Comment					
Slope damage due to vehicle traffic.

Looking southeast at slope damage on waterward slope.

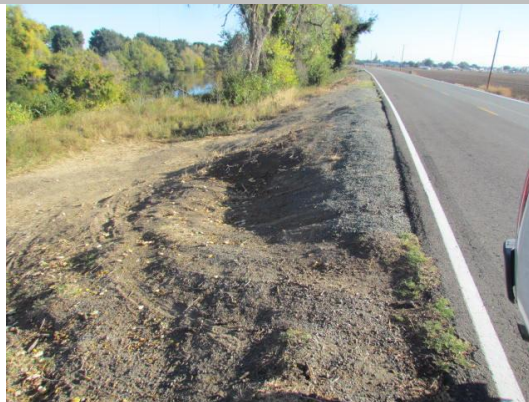
Photo 2 of 2 : SP_2018_RD0563_210_143_20180305_00121.jpg

Looking northwest at slope damage on waterward slope.

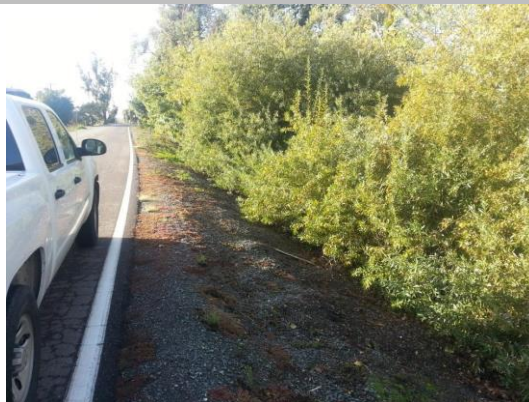
Photo 1 of 2 : SP_2018_RD0563_210_3_20180305_00001.jpg

Looking east at untrimmed trees on waterward slope. (Fall 2016)

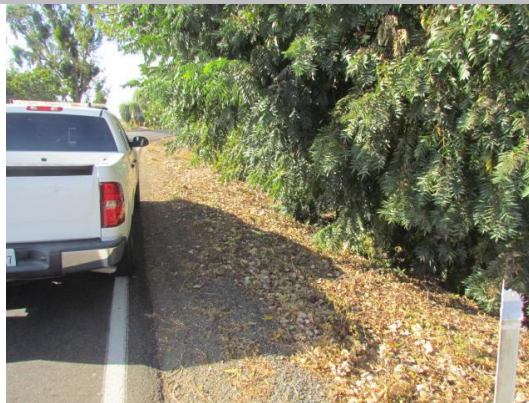
Photo 2 of 2 : SP_2018_RD0563_210_3_20180305_00002.jpg

Looking east at untrimmed trees on waterward slope and toe. (Spring 2016)

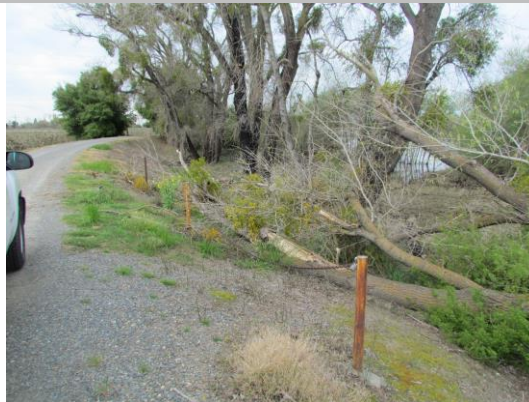
Photo 1 of 1 : SP_2018_RD0563_210_120_20180305_00099.jpg

LM Start	0.88	Rating **	M	Issue No.	120
LM End	0.88	Issue Type +	Ma	Location *	WS
Category	Earthen Levee			GPS Latitude/Longitude	
				Start	End
Item	Encroachments			38.225482 °	38.225482 °
				-121.526882 °	-121.526882 °
DWR ID	DWR_RD0563_01_s _ 2017_120				
Comment Code					
TR : Tree or limb					
Inspector Comment					
Fallen tree on waterward slope.

Looking southwest at fallen tree on waterward slope.

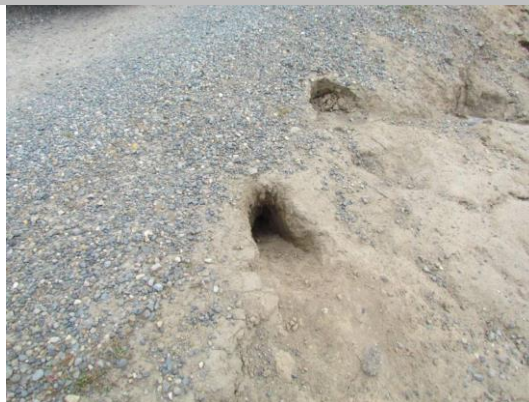
Photo 1 of 2 : SP_2018_RD0563_210_121_20180305_00100.jpg

Looking at typical rodent hole within this reach.

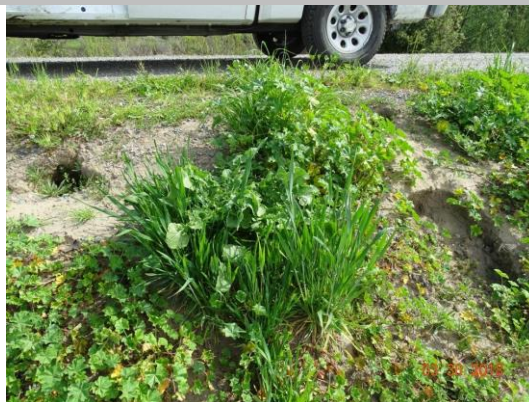
Photo 2 of 2 : SP_2018_RD0563_210_121_20180330_00239.jpg

3/30/2018: Rodent burrows on landside.

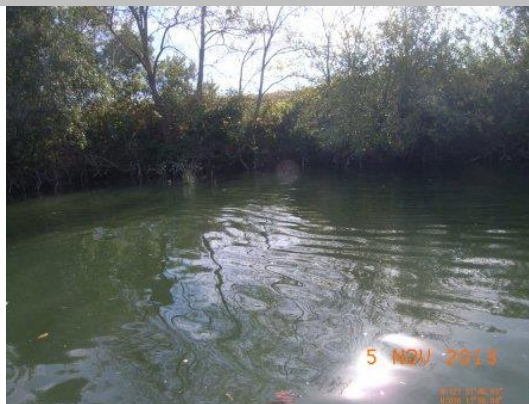
Photo 1 of 1 : SP_2018_RD0563_210_48_20180305_00037.jpg

LM Start	1.02	Rating **	M	Issue No.	48
LM End	1.06	Issue Type +	Ma	Location *	WS
Category	Supplemental			GPS Latitude/Longitude	
				Start	End
Item	2015 USACE Erosion Survey, DRAFT			38.226522 °	38.226808 °
				-121.529094 °	-121.529728 °
DWR ID	DWR_RD0563_01_s_2016_48				
Comment Code					
Inspector Comment					
2011 - Short sections of eroding bank at the waterline and holes in toe of levee. 2012 - Site extended upstream. 2013 - Erosion pockets filled with an insufficient amounts of revetment. 2015: Last observed in 2013. [2015 Site ID: GEO_11-0_L]

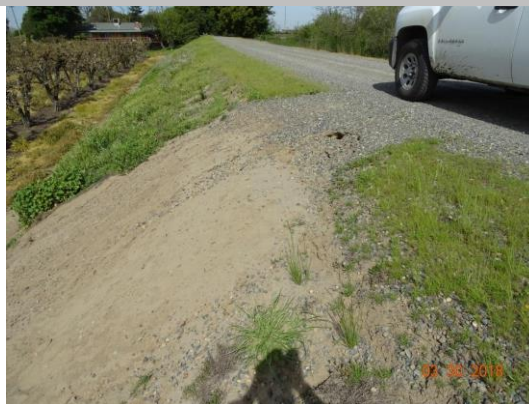
Photo 1 of 1 : SP_2018_RD0563_210_110_20180330_00240.jpg

LM Start	1.03	Rating **	U	Issue No.	110
LM End	1.03	Issue Type +	Ma	Location *	LS
Category	Earthen Levee			GPS Latitude/Longitude	
				Start	End
Item	Animal Control			38.226422 °	38.226422 °
				-121.529410 °	-121.529410 °
DWR ID	DWR_RD0563_01_s_2018_110				
Comment Code					
A3 : No rodents visible, but rodent burrows visible; need to backfill and compact or grout burrows.					
Inspector Comment					
Very large rodent burrow has caused landside shoulder to collapse. Shoulder should be restored.

3/30/2018: Very large rodent burrow causing caving at landside shoulder.

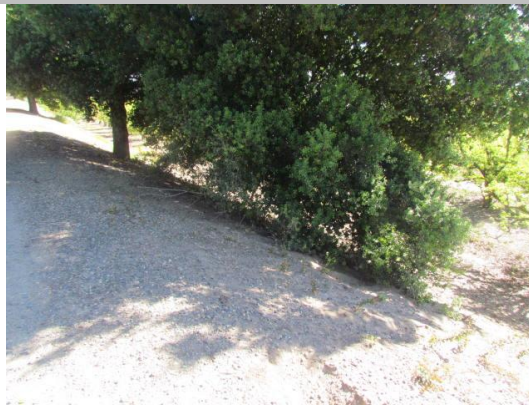
Photo 1 of 1 : SP_2018_RD0563_210_79_20180305_00070.jpg

Looking northeast at untrimmed trees on landward slope and toe.

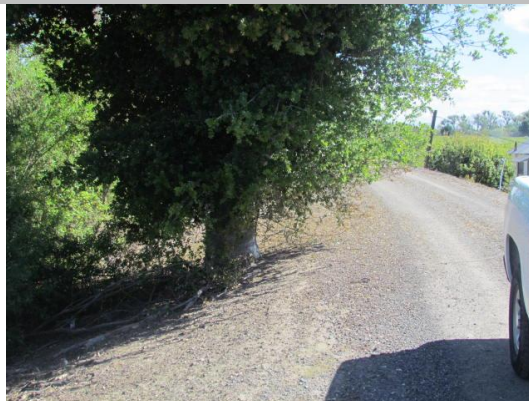
Photo 1 of 1 : SP_2018_RD0563_210_759_20180305_00137.jpg

Looking northwest at untrimmed trees on waterward slope and toe.

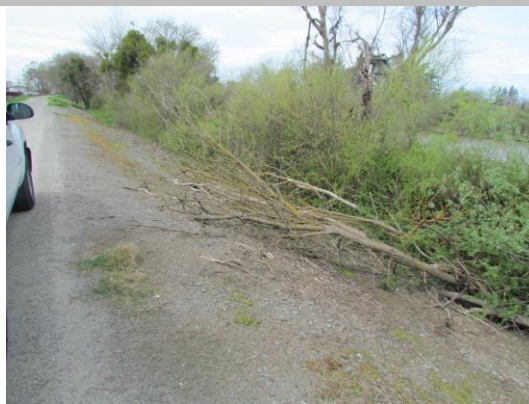
Photo 1 of 1 : SP_2018_RD0563_210_123_20180305_00103.jpg

Looking south at fallen tree on waterward slope.

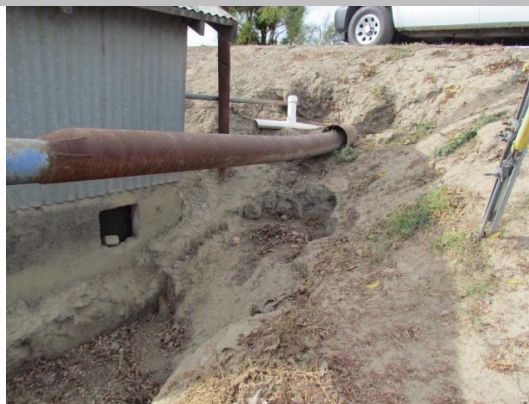
Photo 1 of 2 : SP_2018_RD0563_210_71_20180305_00050.jpg

Looking west at erosion at landside toe and slope next to pump house.

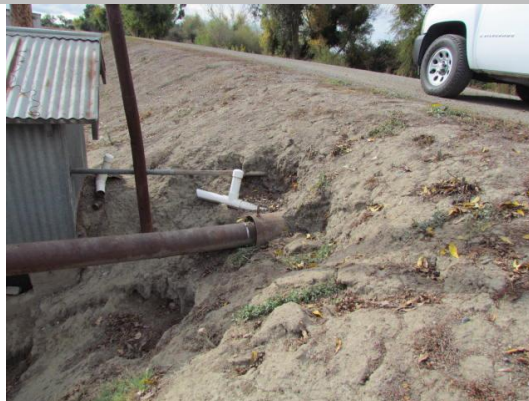
Photo 2 of 2 : SP_2018_RD0563_210_71_20180305_00051.jpg

Looking southwest at erosion around irrigation pipe on landside slope and toe.

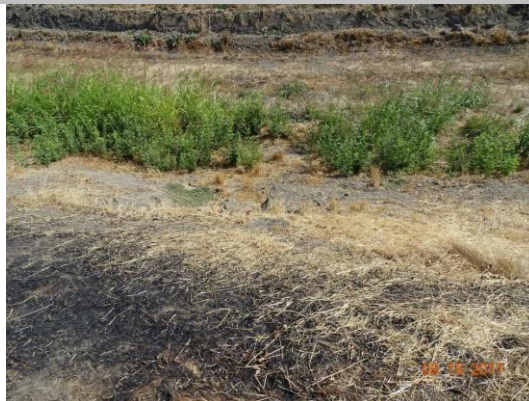
Photo 1 of 1 : SP_2018_RD0563_210_116_20180305_00096.jpg

LM Start	2.25	Rating **	A/W	Issue No.	116
LM End	2.25	Issue Type +	Ma	Location *	LS
Category	Earthen Levee			GPS Latitude/Longitude	
				Start	End
Item	Erosion / Bank Caving			38.217588 °	38.217588 °
				-121.542520 °	-121.542520 °
DWR ID	DWR_RD0563_01_s_2017_116				
Comment Code					
E2 : Schedule repair of erosion site prior to the next inspection.					
Inspector Comment					
LMA found the erosion while on patrol during the February Storm 2017.

Looking east at the landside toe erosion.

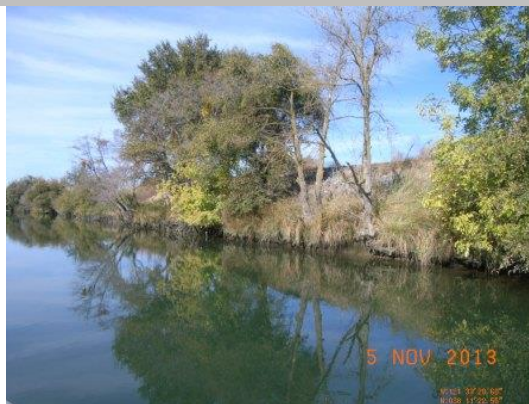
Photo 1 of 1 : SP_2018_RD0563_210_39_20180305_00027.jpg

LM Start	2.61	Rating **	M	Issue No.	39
LM End	2.82	Issue Type +	Ma	Location *	WS
Category	Supplemental			GPS Latitude/Longitude	
				Start	End
Item	2015 USACE Erosion Survey, DRAFT			38.214133 °	38.211737 °
				-121.537778 °	-121.535436 °
DWR ID	DWR_RD0563_01_s_2016_39				
Comment Code					
Inspector Comment					
1997 - Loss of rock at toe; pockets of upper berm erosion; very narrow berm width; toe rock problem; erosion pockets in rock. 2002 - New brush boxes at toe of the worst spots. 2005 - Upstream 200 ft removed because of the wide berm. 2006 - Some rock repair pockets behind the brush boxes at the upstream end. 2010 - Some new erosion. 2013 - New rock placed on the levee slope. 2015: Last observed in 2013. [2015 Site ID: GEO_9-3_L]

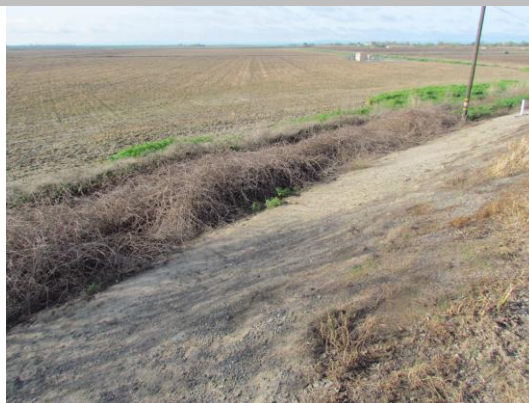
Photo 1 of 2 : SP_2018_RD0563_210_67_20180305_00046.jpg

Looking east at dead berryvines at landward toe. (Spring 2017)

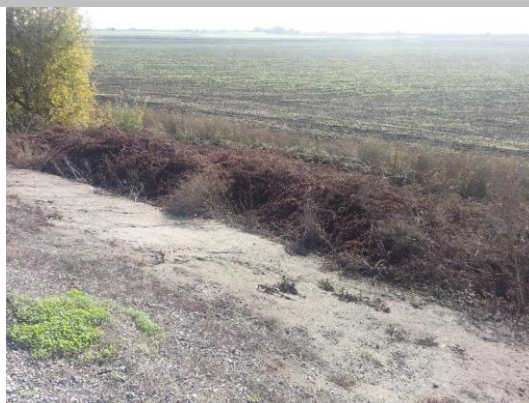
Photo 2 of 2 : SP_2018_RD0563_210_67_20180305_00047.jpg

Looking east at dead berryvines at landward toe. (Fall 2016)

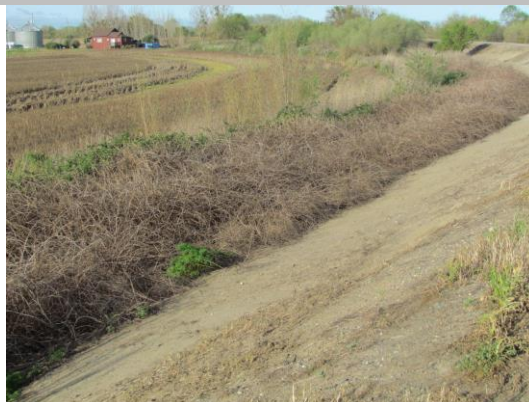
Photo 1 of 5 : SP_2018_RD0563_210_74_20180305_00055.jpg

Looking southeast at dead berryvines along landward toe and berm. (Spring 2017)

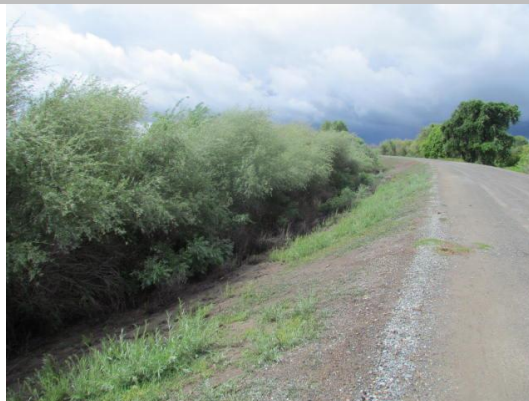
Photo 5 of 5 : SP_2018_RD0563_210_74_20180305_00059.jpg

Looking south at dense vegetation at landward slope and toe. (Spring 2015)

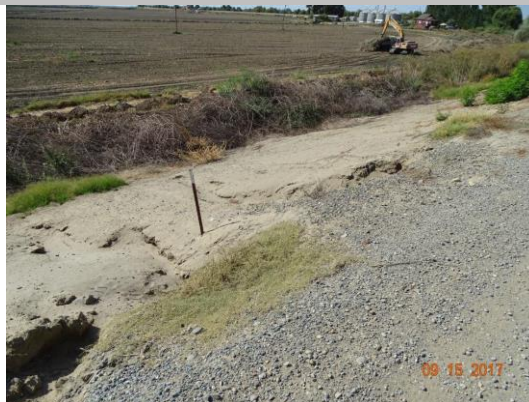
Photo 1 of 5 : SP_2018_RD0563_210_78_20180305_00065.jpg

LM Start	3.06	Rating **	U	Issue No.	78
LM End	3.06	Issue Type +	Ma	Location *	LS
Category	Earthen Levee			GPS Latitude/Longitude	
				Start	End
Item	Slope Stability			38.210240 °	38.210240 °
				-121.537517 °	-121.537517 °
DWR ID	DWR_RD0563_01_s_2012_78				
Comment Code					
S1 : Repair slope instability.					
Inspector Comment					
Slope damage on landside shoulder and slope has been in place for several inspection cycles. Proper drainage should be provided to prevent further erosion, and erosion should be repaired.

Looking southwest at the landside slope.

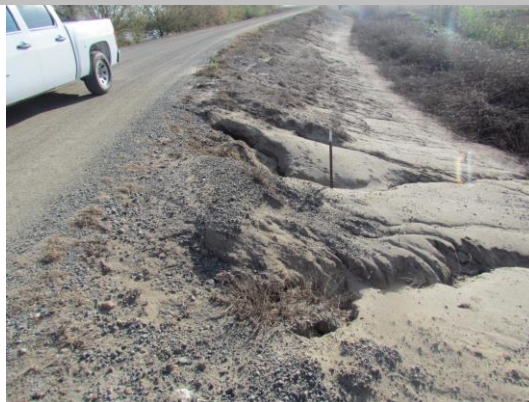
Photo 2 of 5 : SP_2018_RD0563_210_78_20180305_00066.jpg

Looking north at rain runoff erosion on landward slope. (Spring 2017)

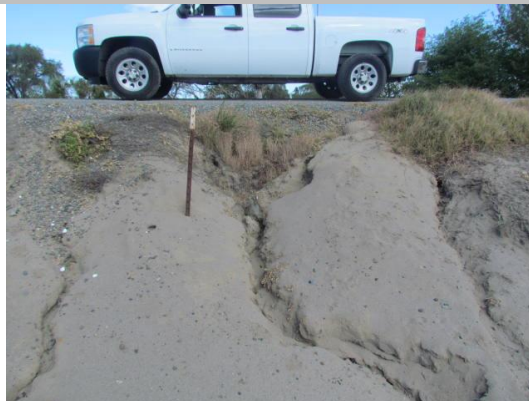
Photo 3 of 5 : SP_2018_RD0563_210_78_20180305_00067.jpg

LM Start	3.06	Rating **	U	Issue No.	78 (cont)	
LM End	3.06	Issue Type +	Ma	Location *	LS	
Category	Earthen Levee			GPS Latitude/Longitude		
				Start		End
Item	Slope Stability			38.210240 °		38.210240 °
				-121.537517 °		-121.537517 °
DWR ID	DWR_RD0563_01_s_2012_78					
Comment Code						
S1 : Repair slope instability.						
Inspector Comment						
Slope damage on landside shoulder and slope has been in place for several inspection cycles. Proper drainage should be provided to prevent further erosion, and erosion should be repaired.

Looking west at rain runoff erosion on landward slope. (Spring 2016)

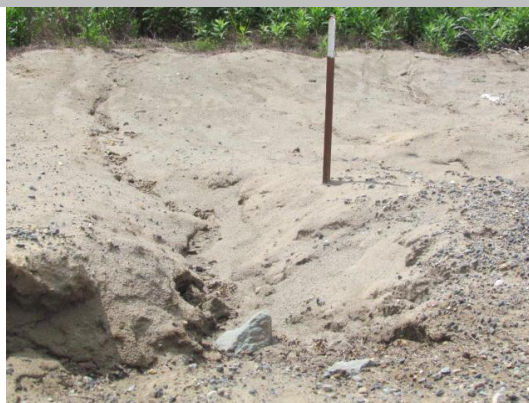
Photo 4 of 5 : SP_2018_RD0563_210_78_20180305_00068.jpg

Looking east at slope erosion. (Updated Spring 2012)

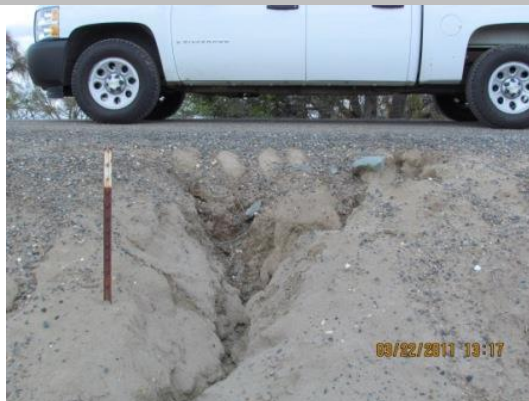
Photo 5 of 5 : SP_2018_RD0563_210_78_20180305_00069.jpg

Looking west at slope erosion cause by runoff on landside slope.

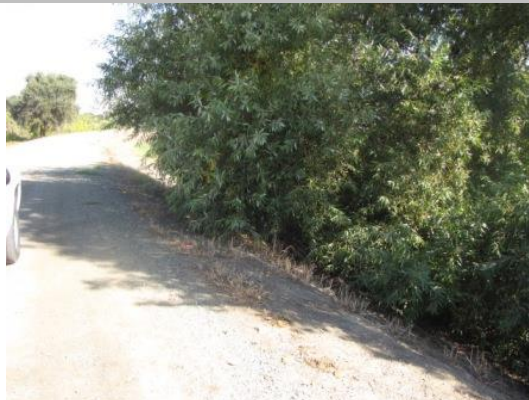
Photo 2 of 2 : SP_2018_RD0563_210_68_20180305_00049.jpg

Looking southeast at dense trees on landside slope and toe.

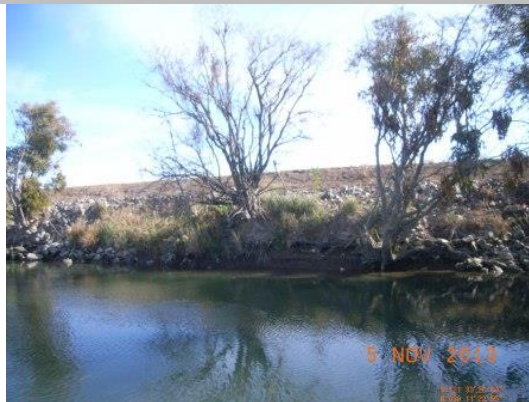
Photo 1 of 1 : SP_2018_RD0563_210_38_20180305_00026.jpg

LM Start	3.91	Rating **	M	Issue No.	38
LM End	4.01	Issue Type +	Ma	Location *	WS
Category	Supplemental			GPS Latitude/Longitude	
				Start	End
Item	2015 USACE Erosion Survey, DRAFT			38.200733 °	38.199925 °
				-121.542571 °	-121.544249 °
DWR ID	DWR_RD0563_01_s_2016_38				
Comment Code					
Inspector Comment					
1997 - Narrow eroding berm upstream of existing rock. 2001 - Staked, low fascine walls at bankline. 2011 - Minor new erosion. Site extended downstream. 2012 - Rock repair failing in one erosion pocket. 2015: Last observed in 2013. [2015 Site ID: GEO_8-3_L]

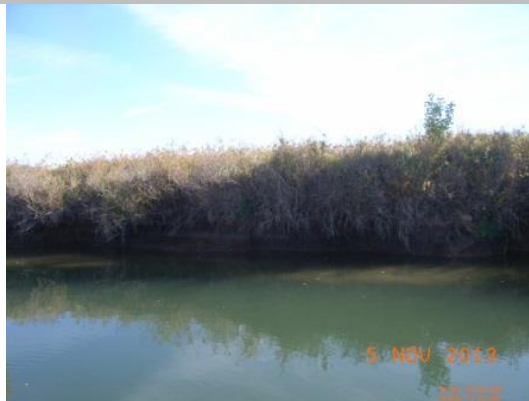
Photo 1 of 1 : SP_2018_RD0563_210_45_20180305_00033.jpg

LM Start	4.98	Rating **	M	Issue No.	45
LM End	5.04	Issue Type +	Ma	Location *	WS
Category	Supplemental			GPS Latitude/Longitude	
				Start	End
Item	2015 USACE Erosion Survey, DRAFT			38.190073 °	38.189524 °
				-121.556307 °	-121.557227 °
DWR ID	DWR_RD0563_01_s_2016_45				
Comment Code					
Inspector Comment					
2009 - Small scallops of erosion into the levee toe behind brush boxes. 2011 - Minor new erosion. 2012 - Site extended upstream to account for addition erosion pockets. 2015: Last observed in 2013. [2015 Site ID: GEO_7-2_L]

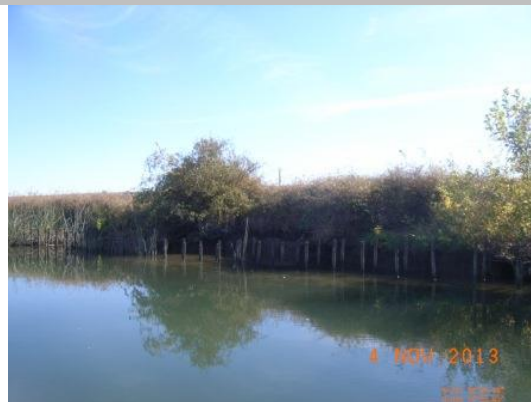
Photo 1 of 1 : SP_2018_RD0563_210_55_20180305_00040.jpg

Comment Code					
Inspector Comment					
1997 - Deep pockets of erosion and narrow berm. Reach is characterized by lots of pockets into the existing berm and/or levee slope. 1999 - Some pockets filled with rock riprap. 2000 - Exposed fabric. 2001 - Staked, low fascine walls at bankline. 2002 - New spot of rock at upstream end. Some new brush boxes. 2005 - Some stone sliding off the underlying geotextile fabric. Some new brush bundles in the brush boxes; some with missing bundles. Some boxes too low relative to high tide. 2009 - Minimal new erosion, site length extended. 2010 - New erosion on downstream end, site extended downstream. 2011 - Sites 6.1, 6.4 and 6.6 were combined. New erosion pockets, site extended to include the erosion in between the old sites. 2012 - Rock has been placed in portions of the bank since last year. 2015: Last observed in 2013. [2015 Site ID: GEO_6-3_L]

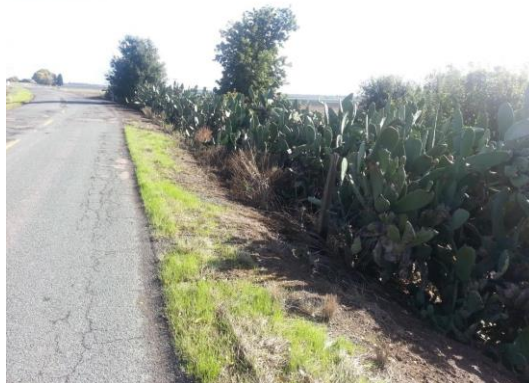
Photo 2 of 2 : SP_2018_RD0563_210_22_20180305_00014.jpg

Looking downstream at dense cactus on landward slope. (Fall 2016)

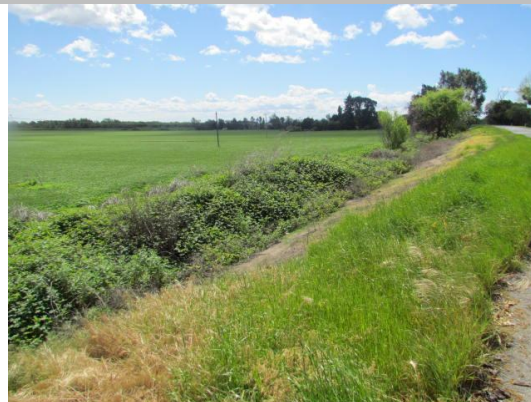
Photo 1 of 1 : SP_2018_RD0563_210_164_20180305_00130.jpg

Looking east at dense vegetation (vines) at landward toe.

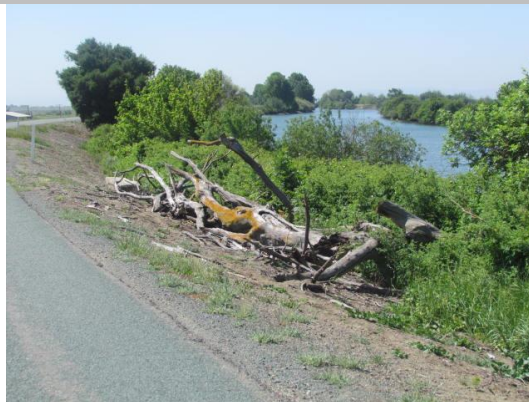
Photo 1 of 1 : SP_2018_RD0563_210_95_20180305_00081.jpg

Looking southwest at prunings on waterward slope.

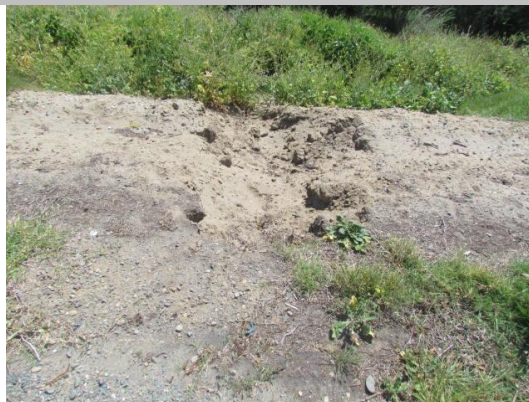
Photo 1 of 1 : SP_2018_RD0563_210_97_20180305_00082.jpg

Looking east at slope erosion on landward shoulder and slope.

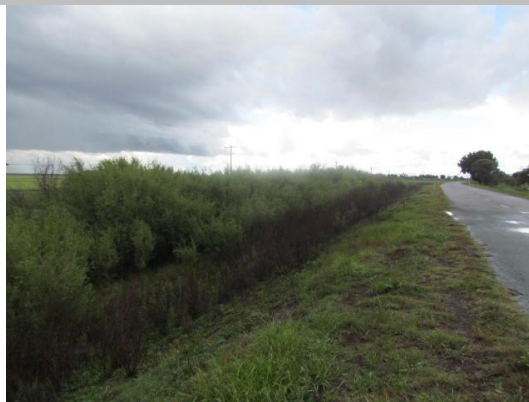
Photo 1 of 5 : SP_2018_RD0563_210_90_20180305_00075.jpg

Looking southeast at dense vegetation at landward toe. (Spring 2015)

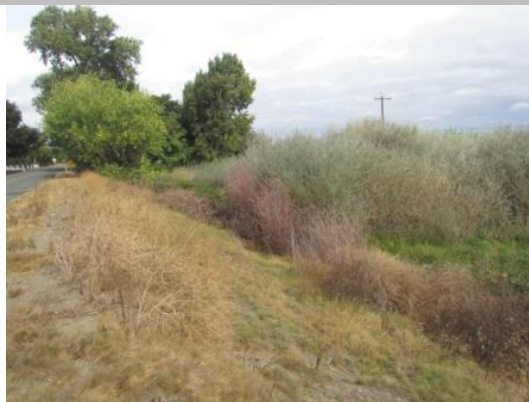
Photo 2 of 5 : SP_2018_RD0563_210_90_20180305_00076.jpg

Looking northeast at dense vegetation on landside toe.

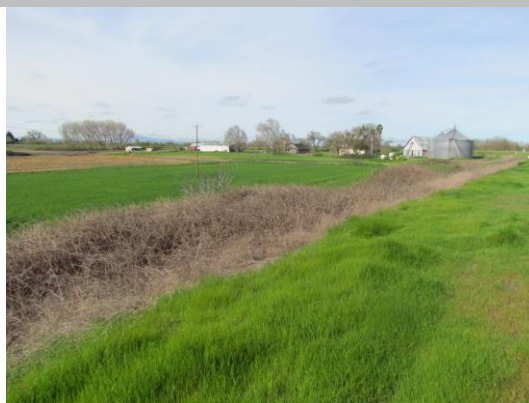
Photo 2 of 3 : SP_2018_RD0563_210_767_20180305_00139.jpg

Looking south at dead vines at landward toe. (Spring 2017)

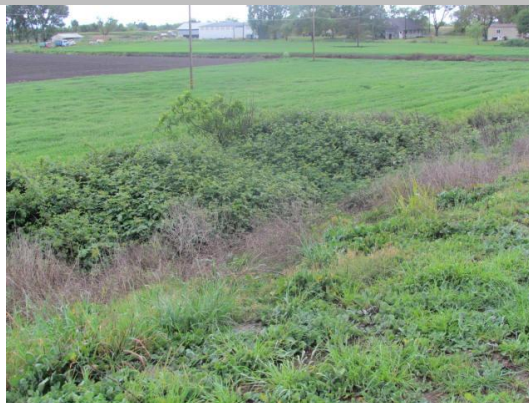
Photo 3 of 3 : SP_2018_RD0563_210_767_20180305_00140.jpg

Looking south at dense wild vines at landward toe. (Fall 2016)

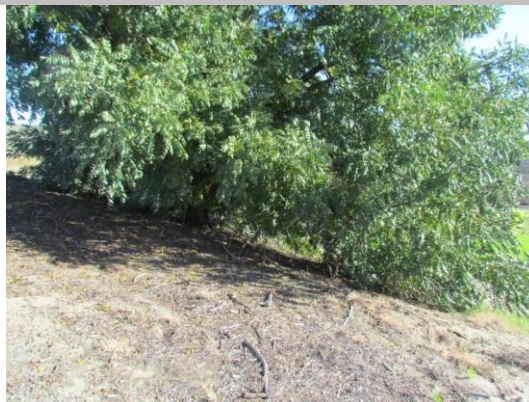
Photo 2 of 2 : SP_2018_RD0563_210_768_20180305_00142.jpg

Looking at untrimmed tree on landward slope.

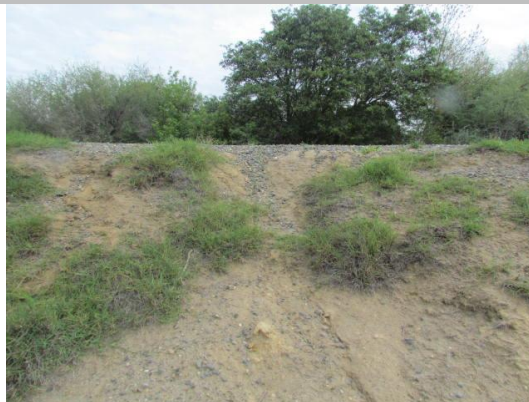
Photo 1 of 2 : SP_2018_RD0563_210_99_20180305_00084.jpg

Looking west at minor erosion on landward shoulder and slope.

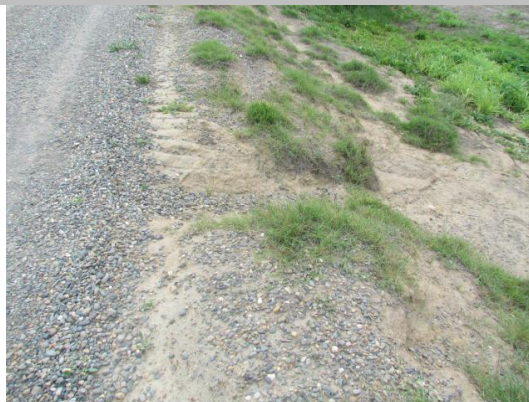
Photo 2 of 2 : SP_2018_RD0563_210_99_20180305_00085.jpg

Looking north at minor erosion on landward shoulder and slope.

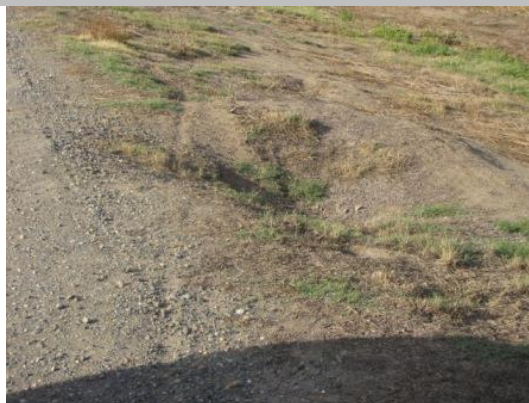
Photo 1 of 4 : SP_2018_RD0563_210_76_20180305_00061.jpg

Looking northeast a depression on landside shoulder and slope above 10" irrigation pipe four feet below crown.

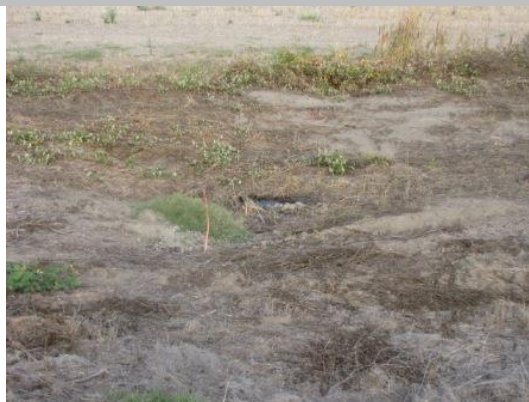
Photo 2 of 4 : SP_2018_RD0563_210_76_20180305_00062.jpg

Looking east at water ponding at landside toe just above 10" irrigation pipe.

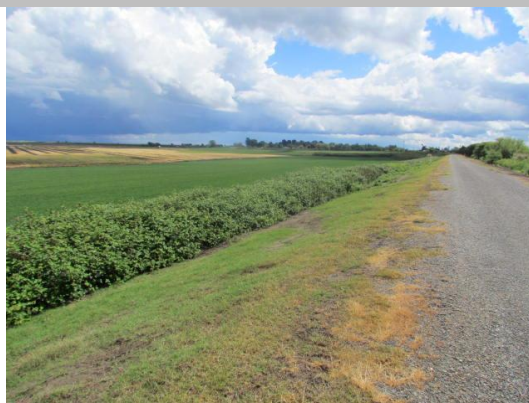
Photo 3 of 3 : SP_2018_RD0563_210_770_20180305_00146.jpg

Looking southeast at dense vegetation at landward toe. (Spring 2015)

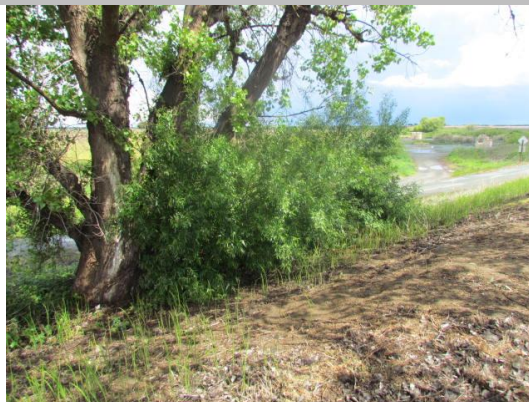
Photo 2 of 2 : SP_2018_RD0563_210_47_20180305_00036.jpg

Looking northeast at untrimmed tree at landward slope. (Spring 2015)
